NDI No. PA 00208  
PENN DER No. 26-70

FAIRCHANCE RESERVOIR DAM  
BOROUGH OF FAIRCHANCE

PHASE I INSPECTION REPORT  
NATIONAL DAM INSPECTION PROGRAM

APRIL 1980

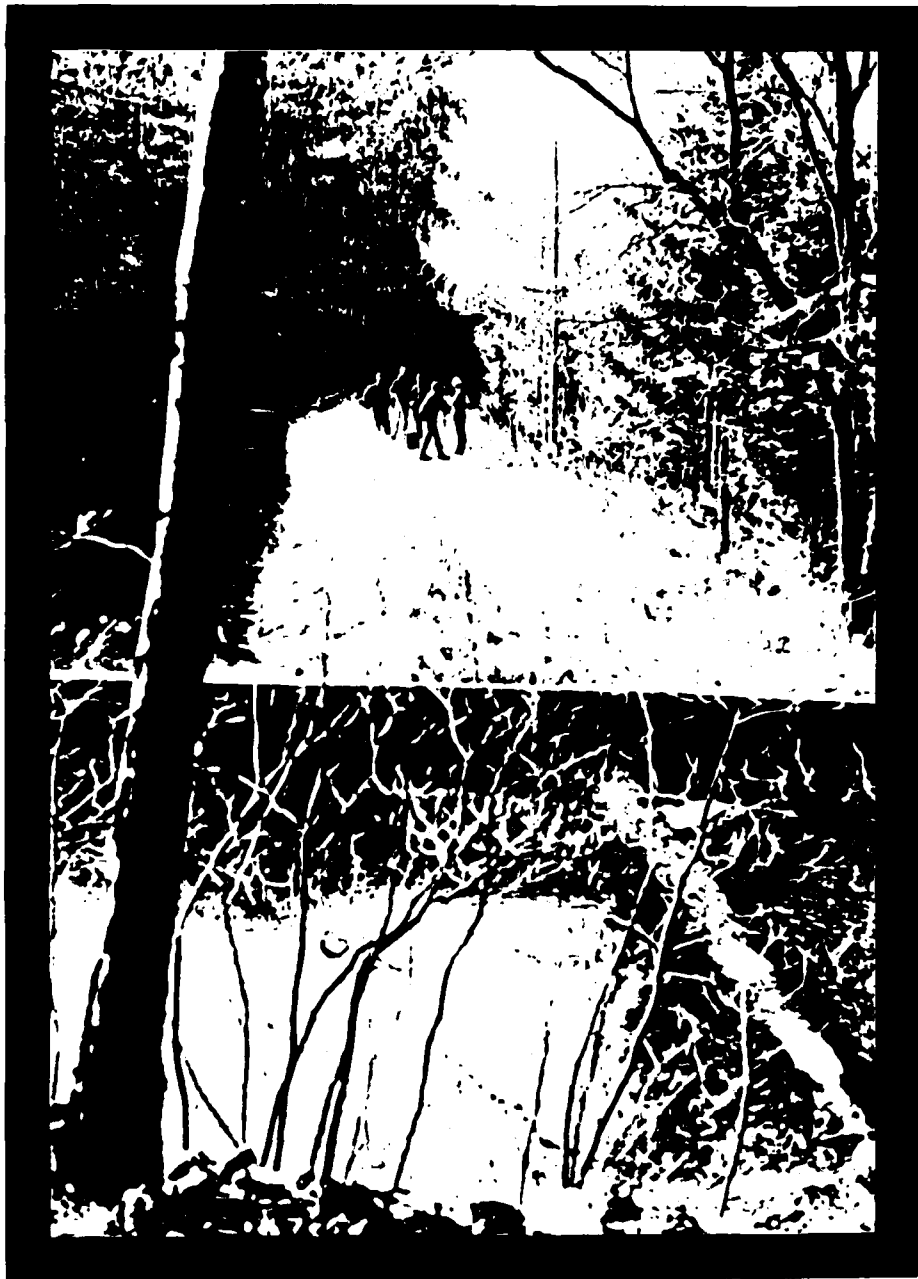
OVERVIEW

Based on a review of available design information and visual observations of conditions as they existed on the date of the field inspection, the general condition of the Fairchance Reservoir dam is considered to be fair.
